**DEPARTMENT OF TRANSPORTATION**

Contract #: 04-0120F4Cty: SF/ALA Rte: 80 PM: 13.2/13.9File #: 1.28**WELDING INSPECTION REPORT****Resident Engineer:** Casey, William**Address:** 333 Burma Road**City:** Oakland, CA 94607**Report No:** WIR-028445**Date Inspected:** 17-Sep-2012**Project Name:** SAS Superstructure**OSM Arrival Time:** 700**Prime Contractor:** American Bridge/Fluor Enterprises, a JV**OSM Departure Time:** 1930**Contractor:** American Bridge/Fluor Enterprises, a JV**Location:** Job Site**CWI Name:** See below.**CWI Present:** Yes No**Inspected CWI report:** Yes No N/A**Rod Oven in Use:** Yes No N/A**Electrode to specification:** Yes No N/A**Weld Procedures Followed:** Yes No N/A**Qualified Welders:** Yes No N/A**Verified Joint Fit-up:** Yes No N/A**Approved Drawings:** Yes No N/A**Approved WPS:** Yes No N/A**Delayed / Cancelled:** Yes No N/A**Bridge No:** 34-0006**Component:** OBG**Summary of Items Observed:**

**OBG 12W**

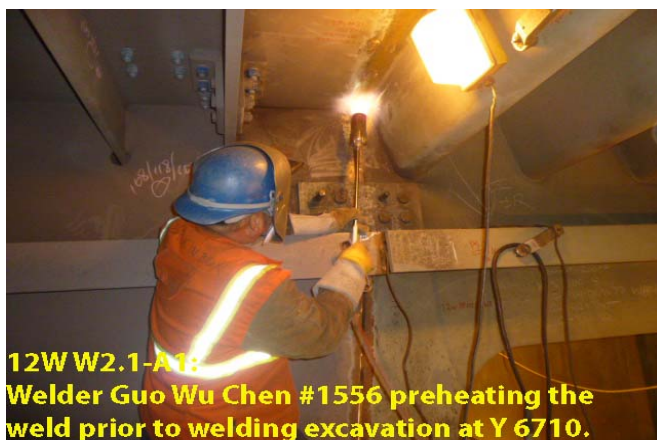
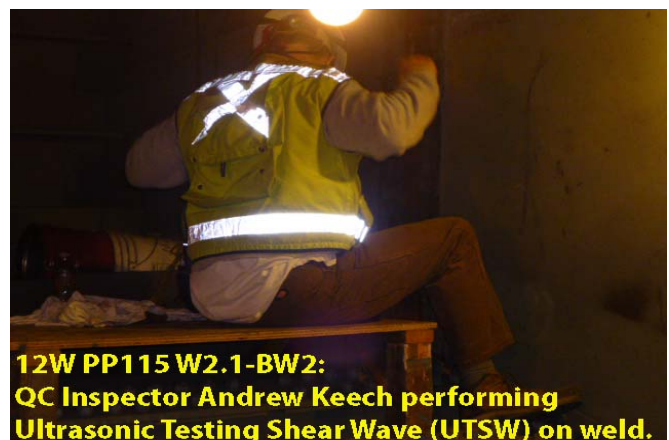
Welder Jin Quan Huang was observed continuing welding on weld 12W PP112 W2.1-BW1 (3G, CJP). The welder was observed utilizing Caltrans approved Welding Procedure Specification's (WPS) ABF-WPS-D15-1030 and preheating the weld to the over 150 degrees Fahrenheit prior to starting his weld. Welder Jin Quan Huang was also observed grinding and welding Visual Testing (VT) rejects on weld 12W W2.1-A1 using Welding Procedure Specification (WPS) ABF-WPS-D15-1001-Repair. The preheating temperatures and other welding parameters appeared to be in order as observed and in compliance with the noted Welding Procedure Specification's (WPS) above.

Welder Guo Wu Chen #1556 was observed grinding and welding Visual Testing (VT) rejects on weld 12W W2.1-A1 using Welding Procedure Specification (WPS) ABF-WPS-D15-1001-Repair. The preheating temperatures and other welding parameters appeared to be in order as observed and in compliance with the noted Welding Procedure Specification's (WPS) above.

- Excavation at Y location 6005 (30 x 10 x 3mm Deep, MT Accept.)
- Excavation at Y location 6710 (22 x 10 x 5mm Deep, MT Accept.)
